**07-121844 ("Rte 5 Widening")
07-LA-5-42.8/47.3
from 5/134 to Magnolia**

ASSISTANT STRUCTURE REPRESENTATIVE REPORT CCO #194

Structure Location & Description of Operation: Providencia OH 53-1085

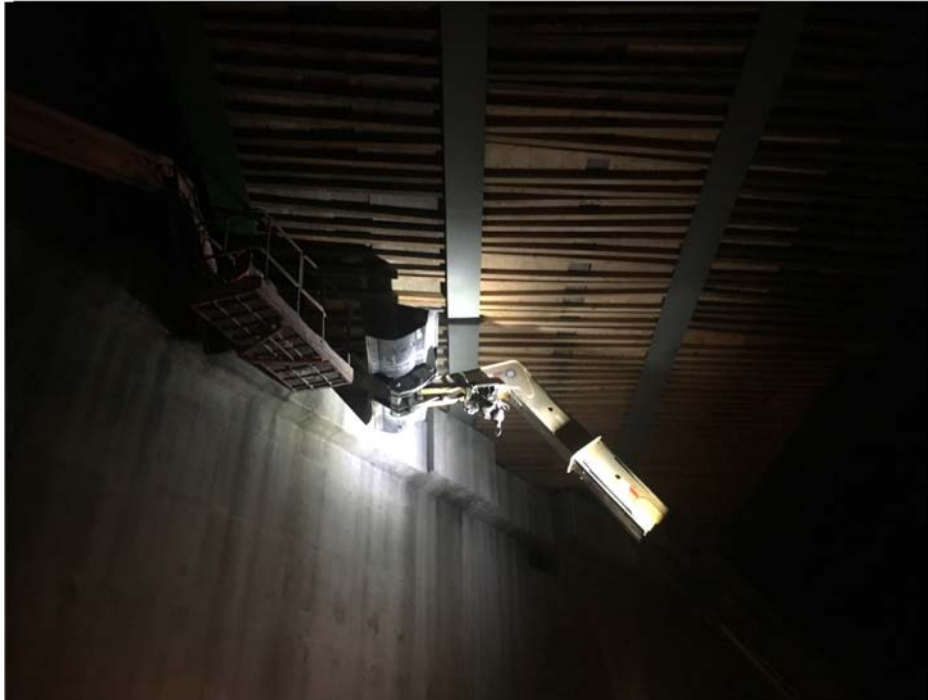
Removing concrete debris

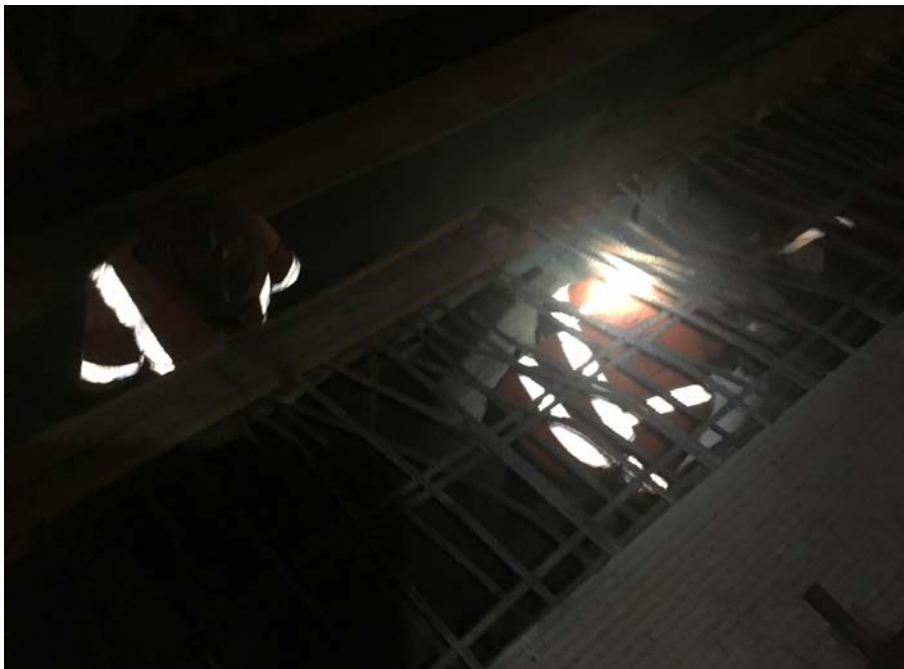
Removing concrete debris
